② National Dam Inspection Program, Auburn Dam

AUBURN DAM, SCHUYLKILL COUNTY,
PENNSYLVANIA

(NDS I.D. NO. PA 00670)
(DER I.D. NO. 54-163)

PHASE I INSPECTION REPORT,
NATIONAL DAM INSPECTION PROGRAM

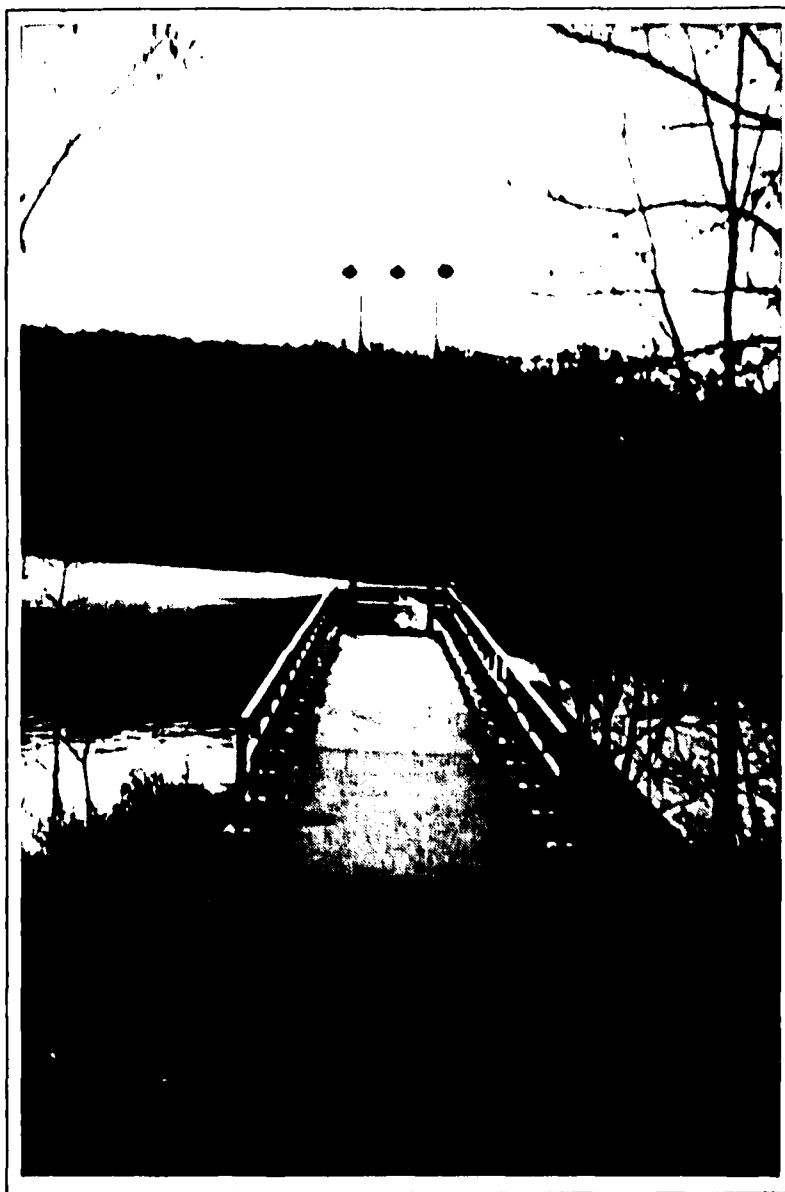
PHOTOGRAPH NO. 3

The backfill around the right non-overflow section and the adjacent embankment, shown in Photograph 3, appears to be in good condition with no significant erosion or sloughing. The fill around the left non-overflow section is protected by derrick stone, shown in Photograph 11, which ranges from four to eight feet thick. It is noted that the interstices of this large stone are not filled with smaller stone. The derrick stone was designed to overlay a two foot thick layer of rock spoil, which in turn overlies a one foot thick layer of gravel bedding. A small amount of erosion was noted at the downstream toe of the left spray wall, shown in Photograph 15, probably resulting from a combination of wave action and foot traffic.

ABUTMENT AND TOP OF NON-
OVERFLOW SECTION, RIGHT
SIDE.

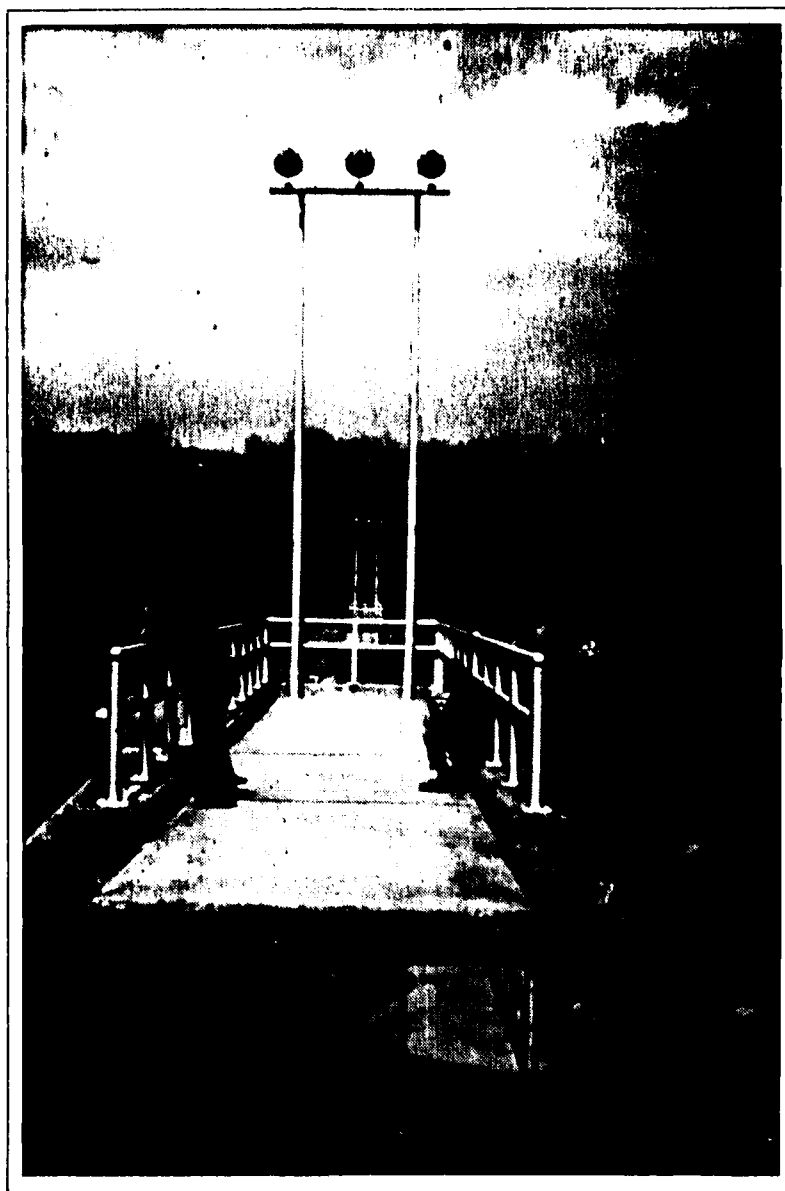
PHOTOGRAPH NO. 10

EMBANKMENT CREST AND TOP OF
LEFT NON-OVERFLOW SECTION.
